# Milton's Commemorative Gold Watches – A Mystery from the Past

## **Project Supplementary Report: Watch Details**

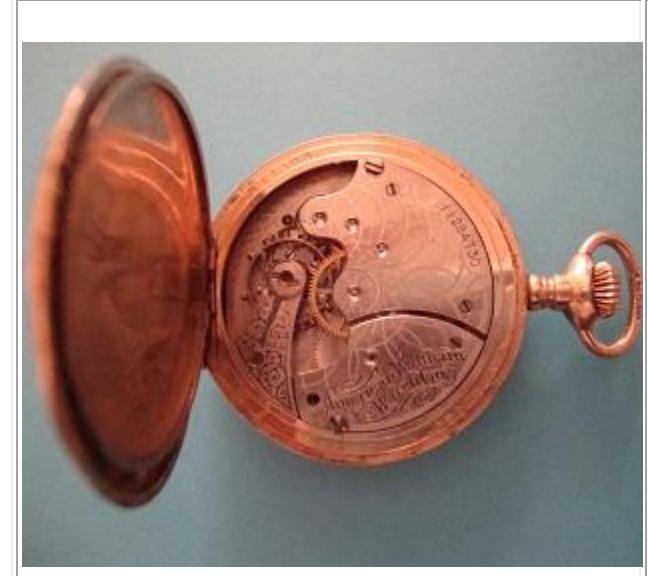
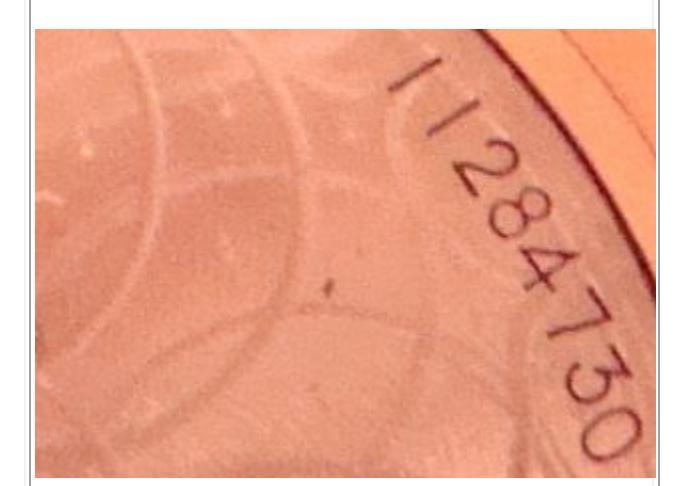
The watch as it first appeared in the photographs for the report and web site:	Front Face: Waltham (American Watch Company, Waltham Massachusetts) 12 hour clock markings only Glass is missing, second hand is missing Case: Gold cover marked 1128668 (inside) Front and rear case patter is Maple Leaf branches Rear Cover Case Inscriptions: CASHIER Unknown "winged emblem" A.W.C. CO. Gold Filled Extra 1128668 Rear Body Inscription: THE GREAT WAR In Memory Of Private E. Baverstock From Citizens of Milton July 1, 1917
Lorne first provided a link to <u>The Internet</u> <u>Horology Club</u> where he also posted information about the Milton Gold Watch project and images of the watches. He then went on to provide guidance as to how to learn more about the watch:	There are a number of markings inside the watch. The image shown here has the larger outer case open on the left side of the image and then the smaller rear cover of the watch. Both covers are visible in the left side of the image. All of the details then shown inside the watch are clear in the alternate large scale images provided. In the lower section the wording is: <i>American Waltham Watch Co.</i> In the upper right ( <i>2 o'clock position</i> ) the watch serial number is clearly visible as:

For larger scale images please see Figure 1 and 2 in the Appendix to this report.

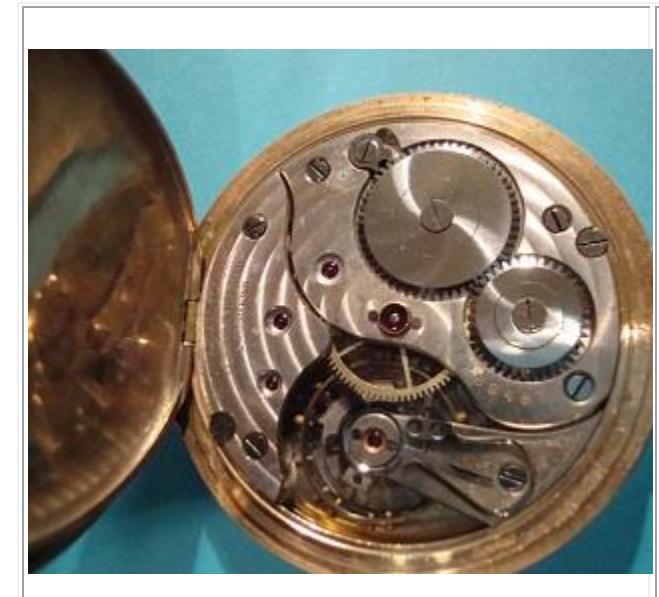
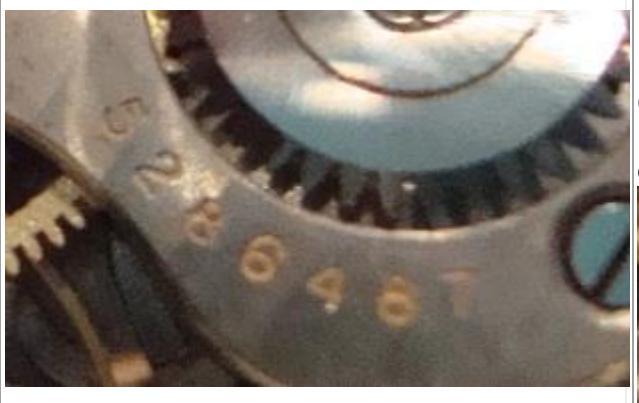
The watch as it first appeared in the photographs for the report and web site:	Front Face: Regina - Swiss Made 12 & 24 hour clock in large and small numerals
	Glass is cracked <b>Case:</b> Gold cover on rear of watch only Rear pattern is a shield or crest <b>Rear Cover Case Inscriptions:</b> SOVEREIGN Gold Filled Maple Leaf with "E" marking emblem
	Gold Filled 224987 <b>Rear Body Inscription:</b> To S. Regan from Town of Milton Great War 1914-19
Lorne provided details on how to carefully open the watch to locate the serial number, which is shown below:	There are two major markings inside the watch. The serial number: <b>5286487</b>
	Lorne provided a link to the OMEGA watch on the web page of the " <u>National</u>

You will note the serial number is in the center of the image, a bit to the right under the gear.

#### See Figure 7 for larger scale.

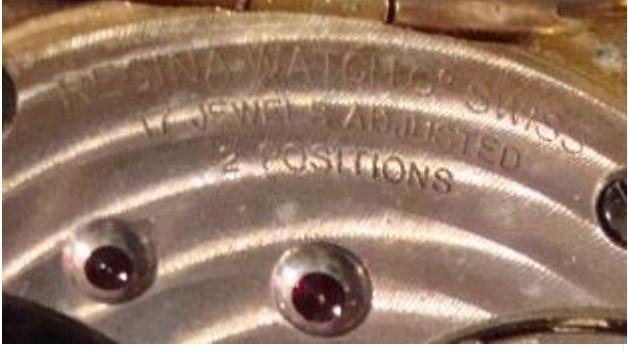
In addition to the serial number, there is additional wording as noted on the far left side of the inner mechanism or at the 9 o'clock position in the photograph to the left:

#### REGINA WATCH Co. SWISS 17 JEWELS ADJUSTED 2 POSITIONS

Here the image has been rotated and cropped to show the wording.

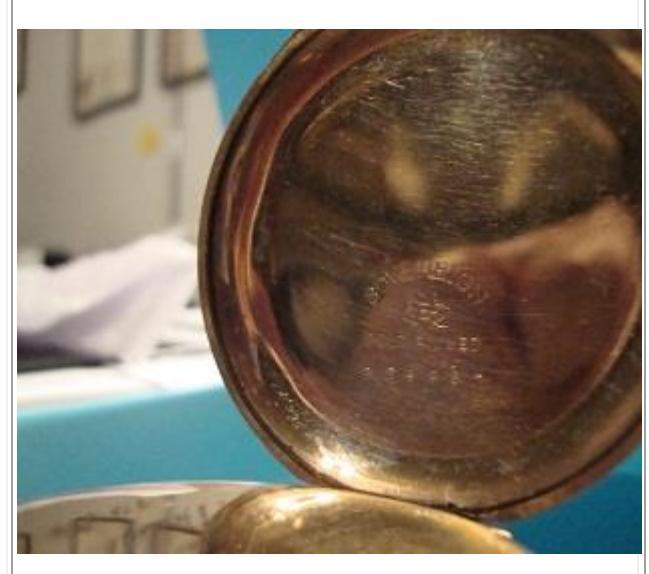
There is a pattern to the gold finish, perhaps anticipating that in some instances there would be an inscription inserted at that point.

wording:

SOVEREIGN Maple Leaf with "E" marking emblem GOLD FILLED 224987

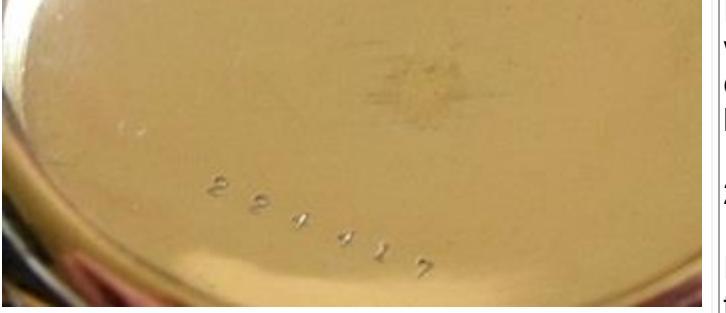
It would appear that the inside of this watch mechanism cover (as compared to the watch case cover) has a serial number:

# 224417

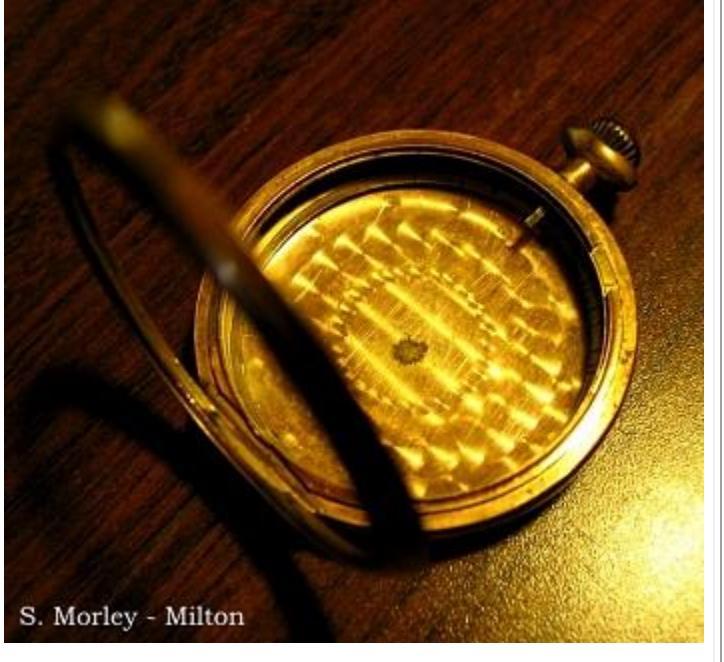
In an earlier photograph (see below), the serial number was not visible. What appeared initially to be a logo above the number appears now to be only a smudge mark.

In an earlier picture of the Morley watch, prior to it being polished by the owner, there appears to be similar finishes to the inside cover of the watch mechanism.

The smudge mark is clearly evident in this photograph but not the number. The number may be blocked from view.

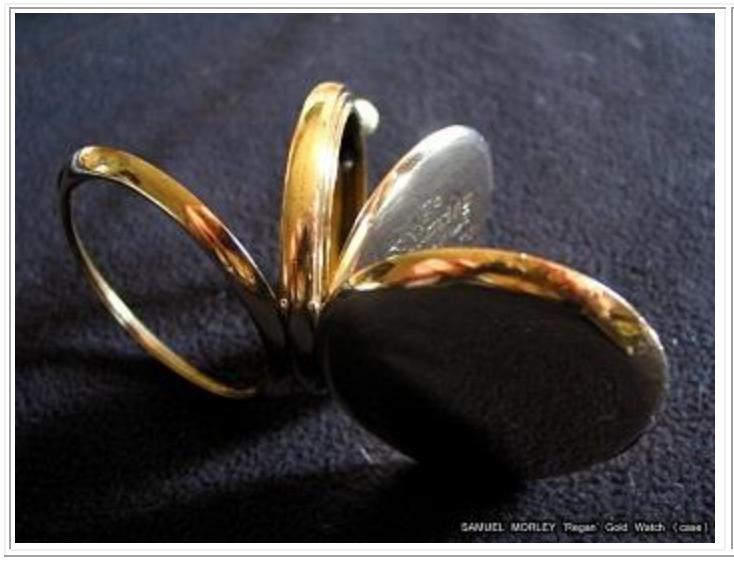
The various components of the Morley watch are visible in this open shot, which is the only image showing the outer case. It is not possible from this image to tell if it is the same as the Regan watch.
